Meeting at Brighton Training Centre

Wednesday 23 January 2018 11:30 am

Purpose of Meeting Discuss removal and risk mitigation of removing koppers logs from Chute area and replace with running rail.
Orientation Jockeys view from within the jump-out barriers
Discussion: Item one – Setout / Materials
 * Aluminium running rail and posts will be switched with plastic mid-February

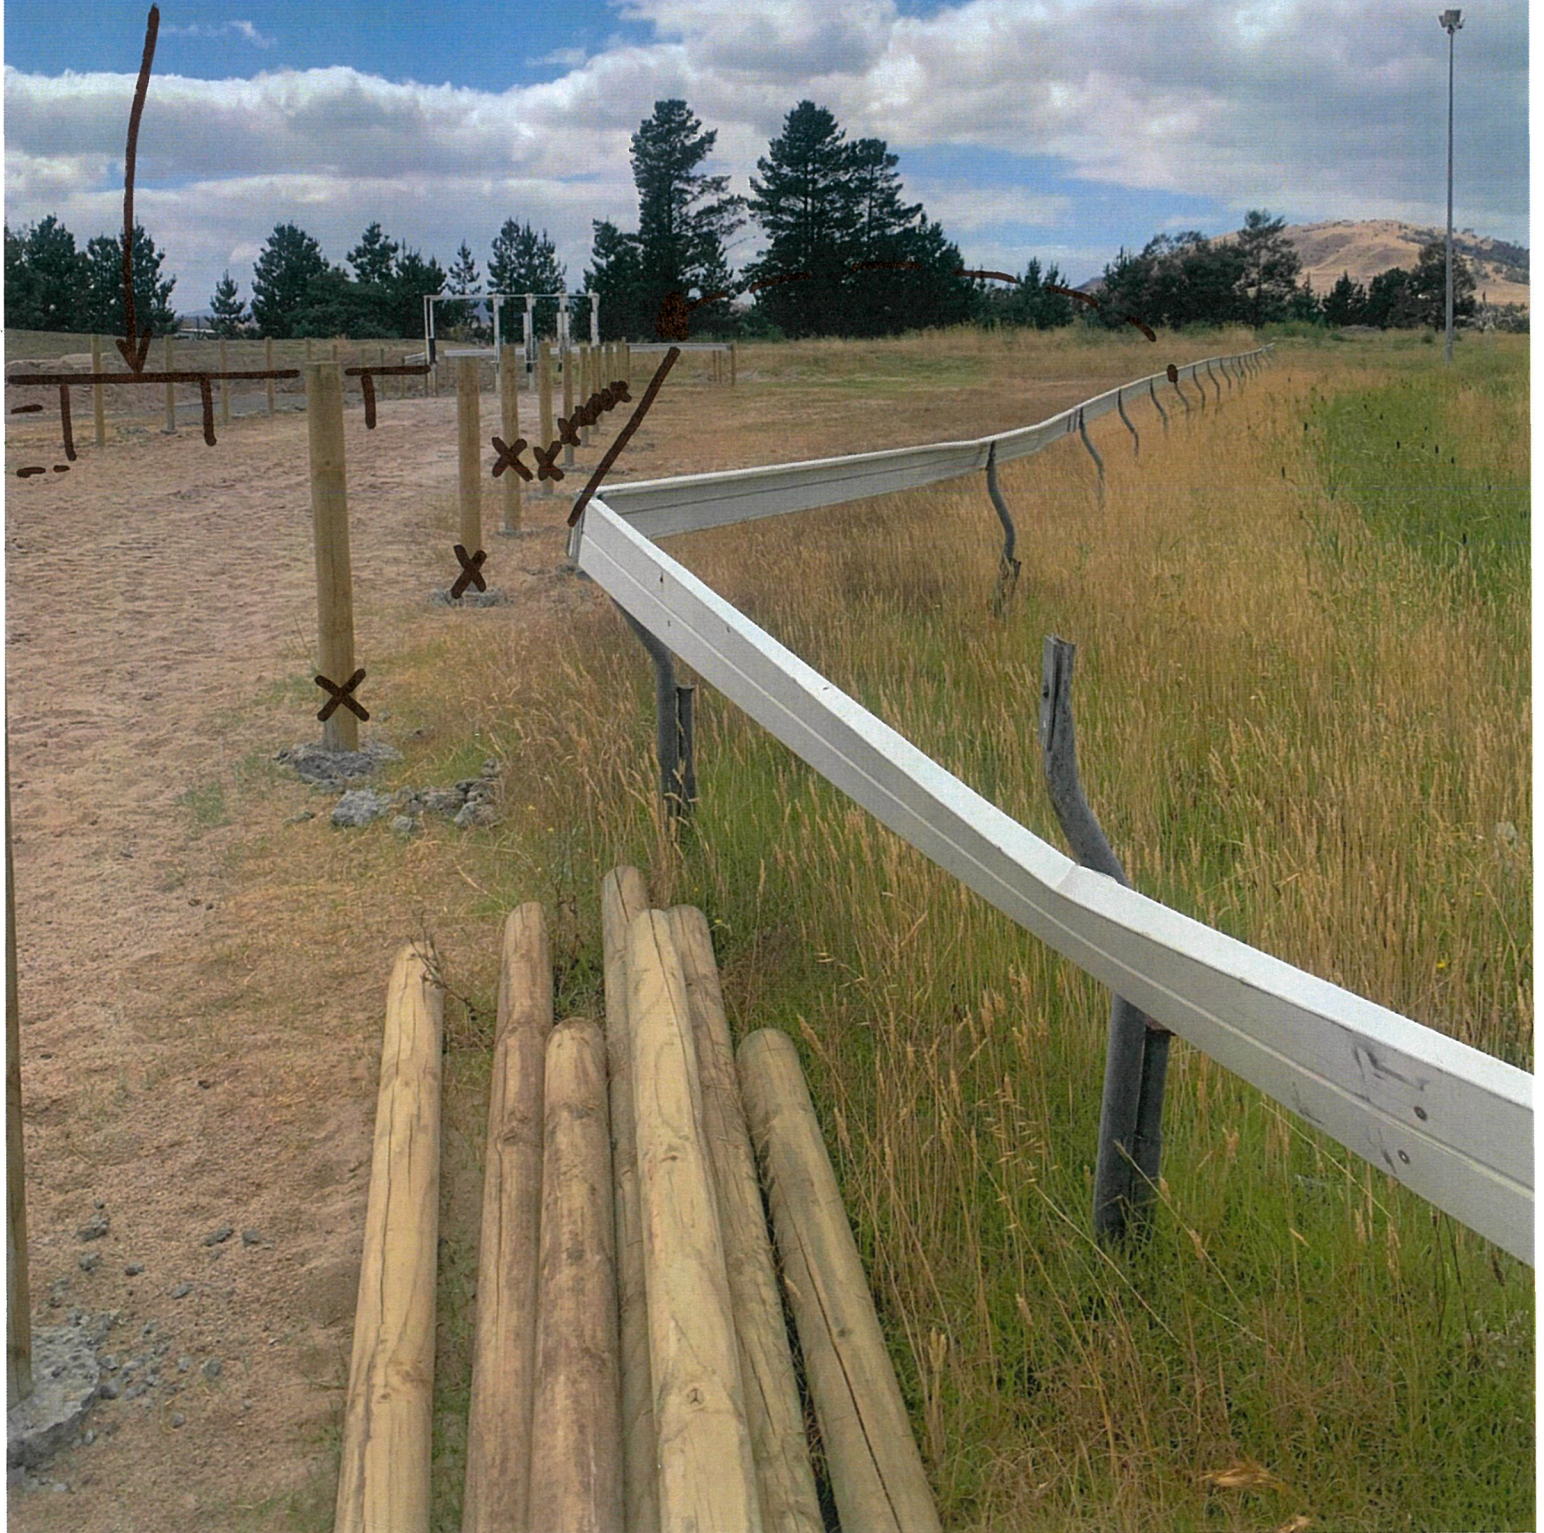
DIAGRAM A

RAIL SET 500mm
INSIDE OF EXISTING POST

- Right hand side of chute to have aluminium* post and rail set 500mm off koppers logs.
- Left hand side koppers logs to be removed completely up to track junction
- Existing aluminium* running rail (see diagram) to pivot along chute perimeter
- Aluminium running rail is to be capped to reduce sharp edges
- Paling gate to be installed between jump out barrier and timber fence on the left-hand side (see diagram B)

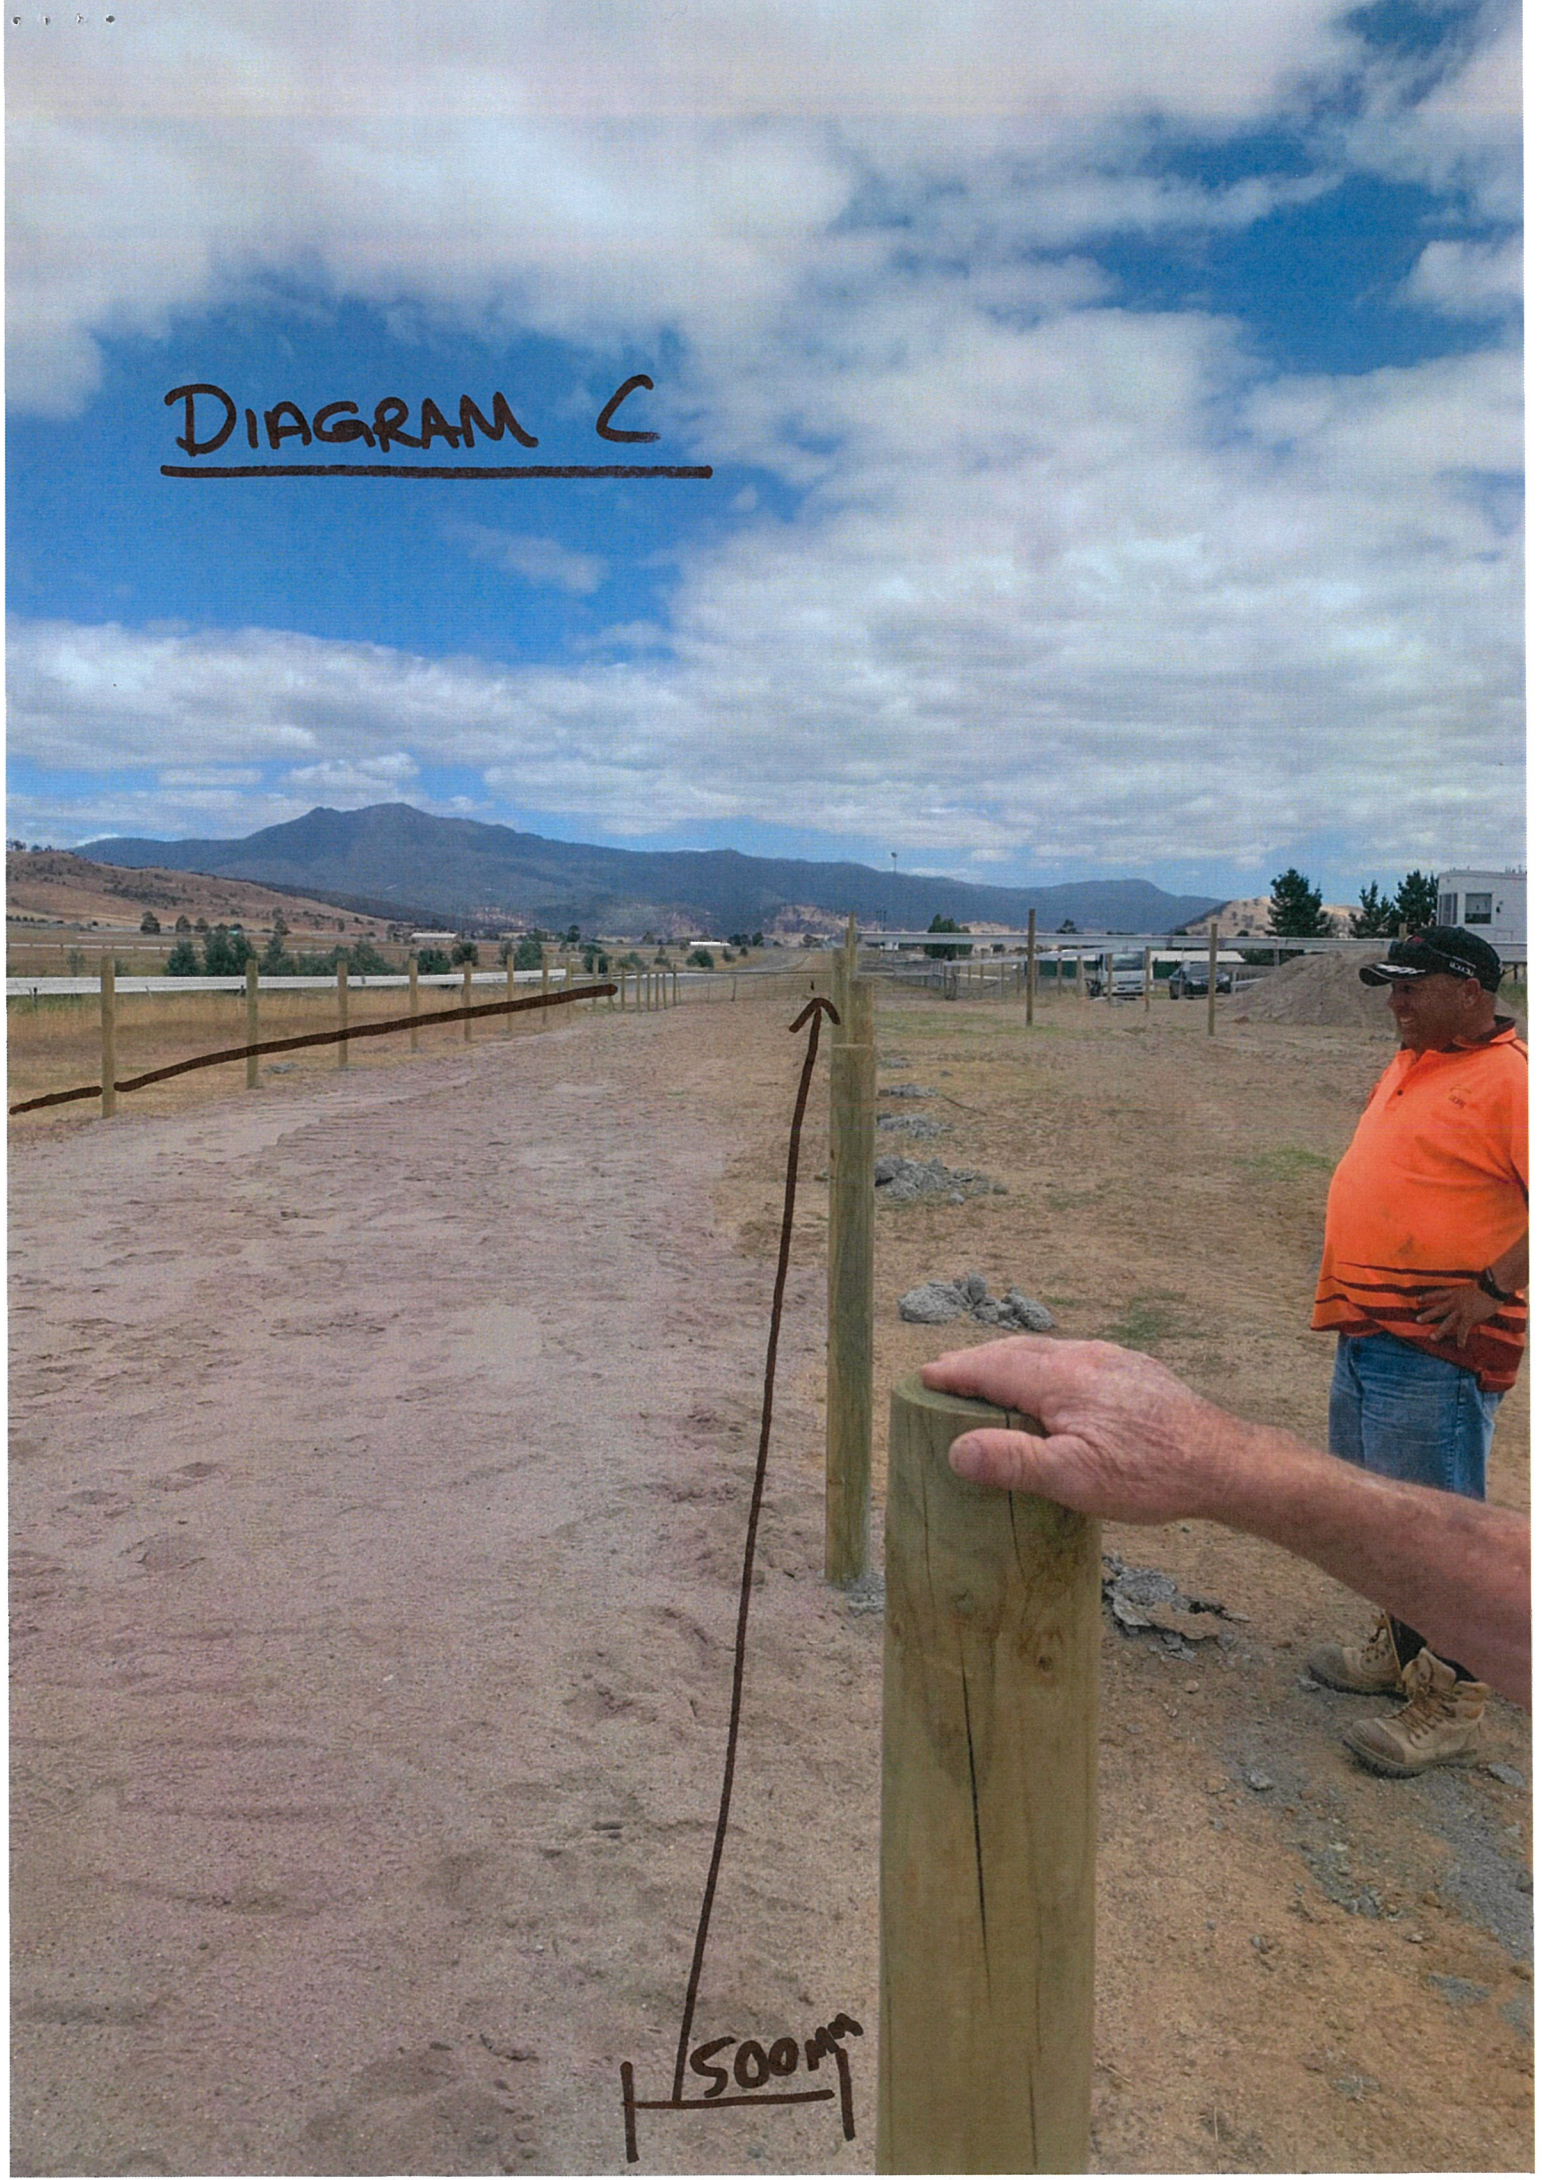
DIAGRAM C

500mm
